SMITHSONIAN INSTITUTION
BUREAU OF AMERICAN ETHNOLOGY
BULLETIN 121

ARCHEOLOGICAL REMAINS IN THE
WHITEWATER DISTRICT
EASTERN ARIZONA

PART I. HOUSE TYPES

By FRANK H. H. ROBERTS, JR.

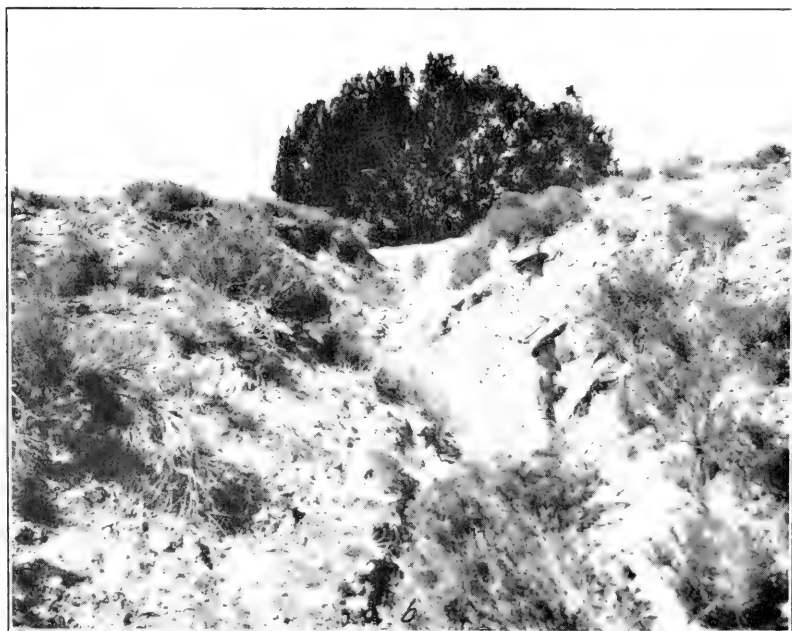
b. Arroyo cut through refuse mound.

of debris was moved to locate the walls at several corners and at a few places along the outside walls, but beyond this no digging was done (pl. 30, *a*). By locating the ends of walls and such corners as were visible, a plan was drawn showing the general outlines of the structures and those features apparent on the surface (fig. 53). The larger of the two main buildings conformed to a rectangular-block plan. The smaller was made up of two units joining so as to form an obtuse angle and provide a court in which a large kiva or ceremonial chamber was located. Near one end of the smaller structure was a great kiva that was connected to it by a wall extending from the corner to the curved wall of the circular chamber. This wall served to accentuate, or perhaps better to complete, the court feature. Some distance from the two large mounds were the remains of two small rectangular structures. They stood in front of the main buildings and seem to have been either single-roomed houses or the lower parts of towers. This could not be determined without excavation. Their location and relation to the other remains is somewhat unusual. The ground plan of the group as a whole has a regularity and symmetry that suggests the builders were following some preconceived idea and not just erecting houses. The refuse mounds for the community were located to the east of the buildings. One of them had been cut by drainage water from the area surrounding the ruins and as a result was traversed by two sizable arroyos. These exposed the stratification and showed the depth of the accumulation (pl. 30, *b*).

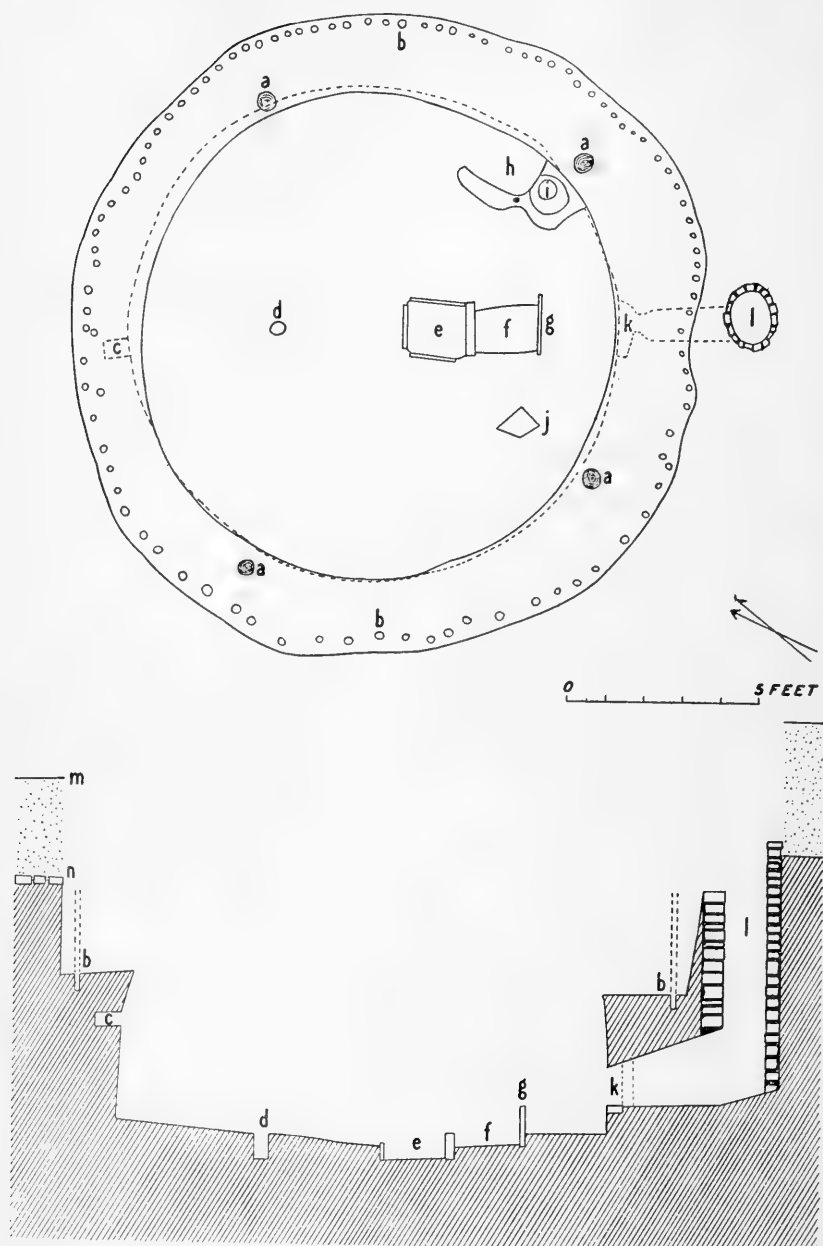
FIGURE 51.—Kiva for unit No. 3. *a*, posts incorporated in bench to reinforce wall; *b*, holes for poles forming wainscoting; *c*, Katcina niche; *d*, sipapu; *e*, fire pit; *f*, ash pit and ladder box; *g*, deflector; *h*, shallow basin in floor; *i*, small circular basin with stone bottom; *j*, stone embedded in floor; *k*, ventilator opening; *l*, ventilator shaft; *m*, present surface; *n*, old ground level.

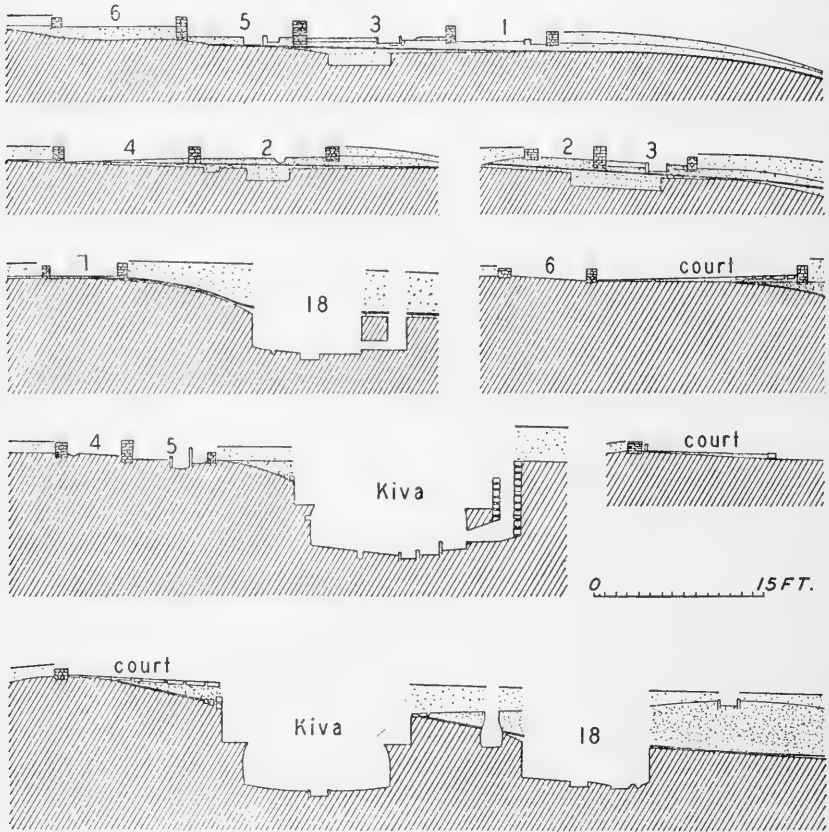
FIGURE 52.—Sections in third unit. Heavy line passing through fill indicates layer of red earth separating occupation level of pit structure and that of subsequent unit.

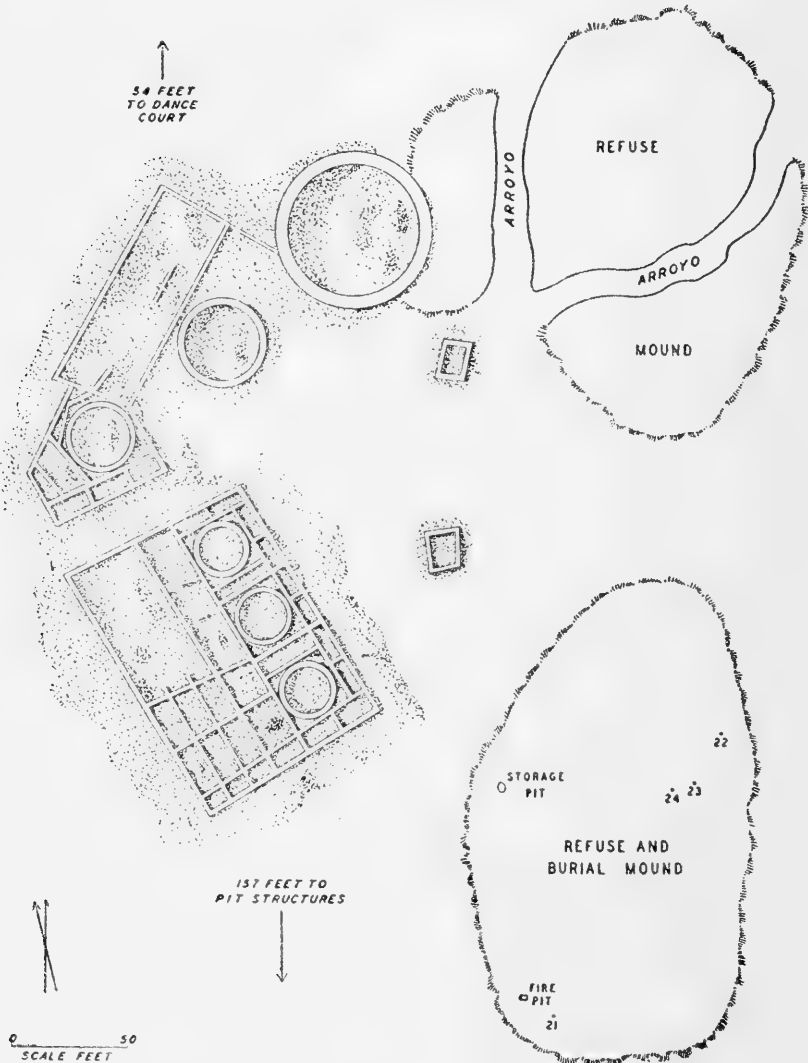
FIGURE 53.—Plan of large ruins of Great Pueblo period.

The original kiva probably was the one located in front of the building. It was rather large compared with the general average

for such structures. There is a possibility that it is a smaller example of the great kiva type, but it is not too large to fall within the range of the ordinary ceremonial chamber. Of course, excavations might reveal various internal features usually associated with great kivas and then there would be no question. The diameter inside the
